ENGINEERING BULLETIN

Problem:

Horizontal auger slugs, mainly in small grains or upon initial start up.

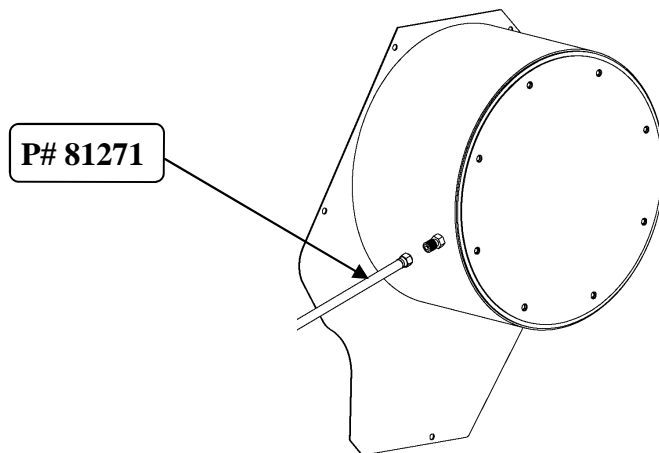
Loosen hydraulic hose **P# 81271**

If there is no pressure gauge installed, you must put one in-line with hydraulic hose **P# 81271**. The following procedure can be used to accomplish this:
